Smoke and Dye Testing Summary

High Level Sewershed

Test ID	Test Type	Date Inspected	Company / Super.	Blower MH	Ground Condition	Notification Made?	Total Length
S1028-041	Smoke	9/5/2008	ADS/TM	S15GG1015MH	Dry	Yes	1,609.80

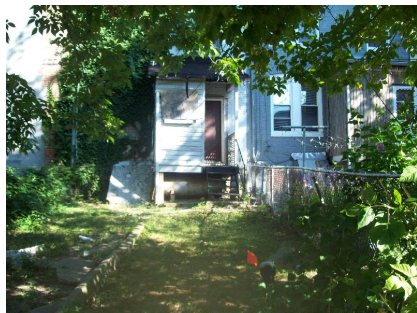
Picture \S1028-041-OB01-P01.jpg

Source Cleanout

Location Yard - back

Comments Smoke from cleanout in back yard. 2653 Loyola Southway

Comments Back of house, 2653 Loyola Southway

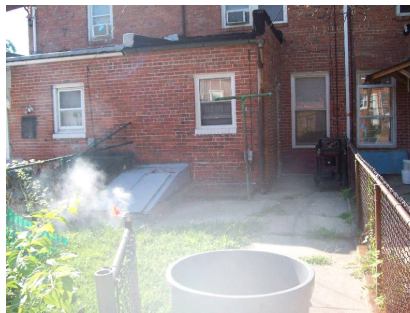
Picture \S1028-041-OB02-P01.jpg

Source Cleanout

Location Yard - back

Comments Smoke from cleanout in back yard. 2502 Oswego Ave

Comments Back of house, 2502 Oswego Ave

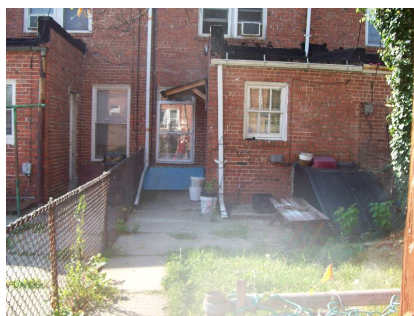
Picture \S1028-041-OB03-P01.jpg

Source Cleanout

Location Yard - back

Comments Smoke from cleanout in back yard. 2504 Oswego Ave

Comments Back of house, 2504 Oswego Ave
